CONSERVATION NEEDS ASSESSMENT REPORT FOR  
**THE PARTHENON AND HISTORIC CONCRETE STRUCTURES AT CENTENNIAL PARK**

PREPARED FOR:  
METROPOLITAN HISTORICAL COMMISSION OF NASHVILLE  
AND  
CENTENNIAL PARK CONSERVANCY

BY  
CULTURAL HERITAGE CONSERVATION LLC  
&  
SILMAN

30 SEPTEMBER 2021

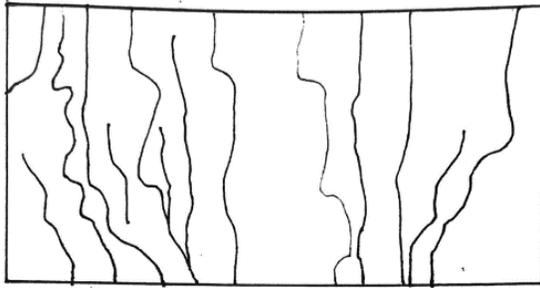
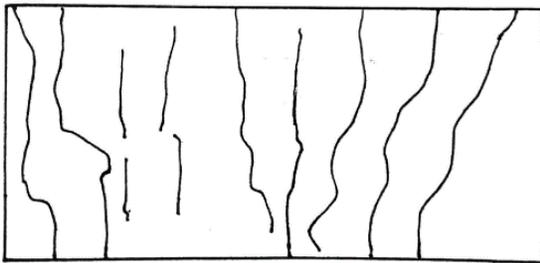
*Figure 5: Myrna Saxe Crack Mapping, 1986.*

They also recorded the cracks in the building wall but cite more analysis and discussion was necessary to recommend a suitable treatment. They noted the large cracks on either side of the east and west doors and provided images of map cracking on the north and south elevations. They cite a possible cause of the cracks is "sinking of foundation in places where the foundation curvature was corrected in the 1920's reconstruction. Possibly with relative loose soil. Crack shape somewhat follows corrected fill areas indicated on Drawings by

FIG. 3: WALL - NORTH ELEVATION - GENERAL CRACK PATTERN

FIG. 4: WALL - SOUTH ELEVATION - GENERAL CRACK PATTERN

Russell E. Hart – George D. Nevins, Foundation Level Corrections, S & E Elevations dated March 25, 1921, and N & W Elevations, dated May 2, 1923.” They recommended crack monitors be installed to determine whether the cracking is active, as well as subsurface investigations to determine any possible continued settlement of the foundation.

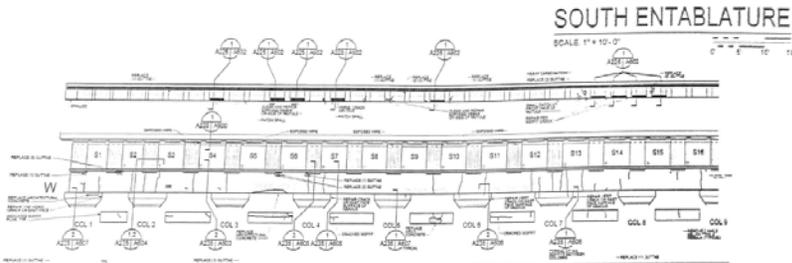
Review of the construction documents shows that in addition to the extensive work done above the architraves, Quinn Evans documented the cracks along the architraves face and underside, as well as areas of the column abaci that required attention. These drawings identify that every architrave soffit (the junction of the element’s vertical face and horizontal underside toward the exterior) was to be pinned with eight 6mm stainless steel helical wall ties that went through the depth of the exposed aggregate finish to the structural concrete. At cracks on the underside of the architraves, 6mm stainless steel Helifix anchors were to be installed on either side of the cracked concrete, every 16” along the length of the cracks.

Figure 6: Crack mapping of part of south entablature by Quinn Evans, 1999.

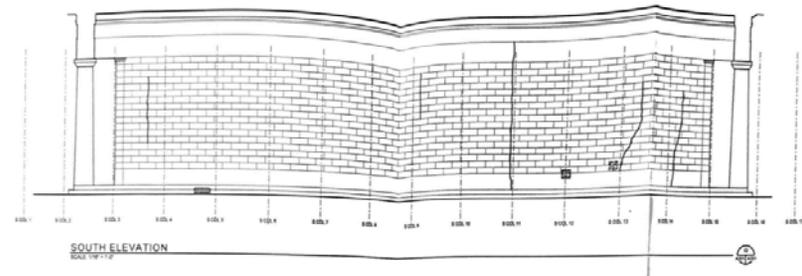
The 2001 construction drawings show four vertical cracks on the north elevation toward the middle of the building, one crack on the east elevation on the north side of the entrance doorway, two cracks on the west elevation, one on either side of the entrance doorway, and five cracks on the south elevation (one toward the west end and four toward the east end) to be repaired by means of removing and patching the full depth of the finish on either side of the crack. Based on comparison to Myrna Saxe's crack map in 1986, the cracks identified on these drawings correspond only to the largest cracks that Quinn Evans recommended repairing with a patch. It is unknown whether the other cracks were repaired.

Figure 9: South elevation map cracking of most extensive cracks, 1999.

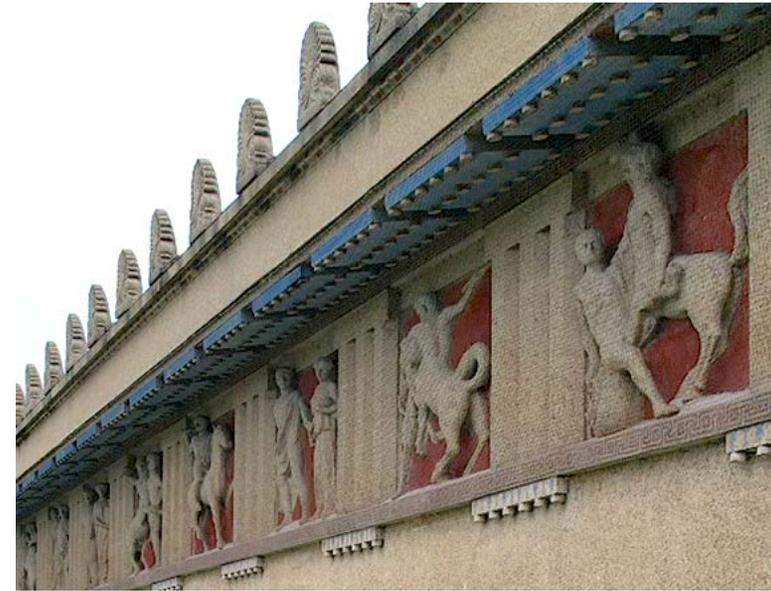
Figure 12: Roof to guttae.

The building was found to be in generally good condition. Roof and pediment restoration work completed in the 1990s appears to be faring well. There are localized areas of rusting at the underside of the guttae, most likely due to rusting of the interior anchors. These were seen at discrete locations along the west elevation and were not extensive around the remainder of the building. Repairs between the guttae and the roof sima, Phases I and II of the work completed from 1997-2001, are in generally good condition with no obvious signs of distress.

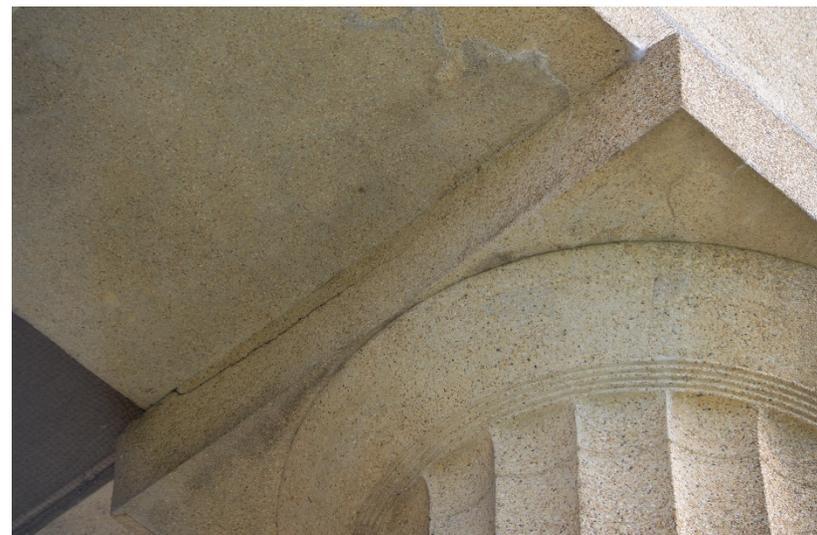
Figure 18: Southeast corner abacus.

It also appears as though some of the cracks have widened since the 2001 work. There is a crack noted as 1/16" wide along the west elevation of the southeast abacus. Today, the crack appears dark with heavy staining and is easily spotted from grade. Up-close review of this crack was not possible so could not be measured with a crack comparator.

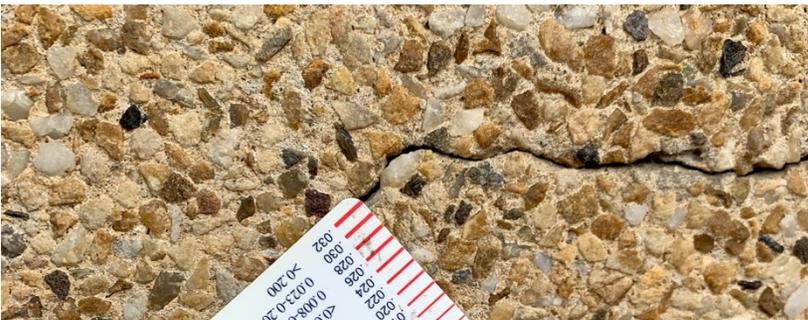
Figure 19: Crack comparator to measure width of wall crack, in inches.

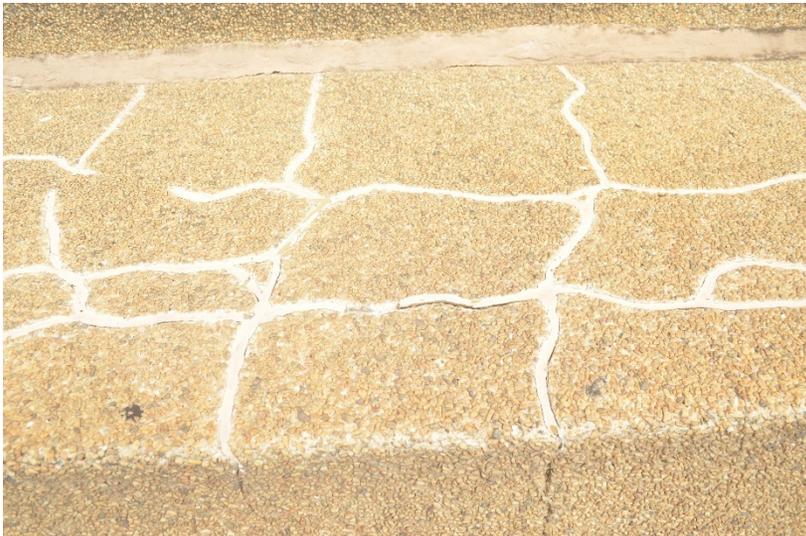
The base of the building has the most conditions to note as the porch and entrance landings have large networks of caulked cracks, the caulk appears to be past its service life. The caulking is extensive and, in most areas, no longer properly adhered to the building substrate. The cracking at the porch is throughout and tends to be at the discontinuities in, or lack of, cold joints in the exposed aggregate finish. At the steps, the most extensive network of horizontal cracking appears to be along the south elevation, south ends of the east and west elevations and the northwest corner steps.

Figure 22: Southern steps, up close.

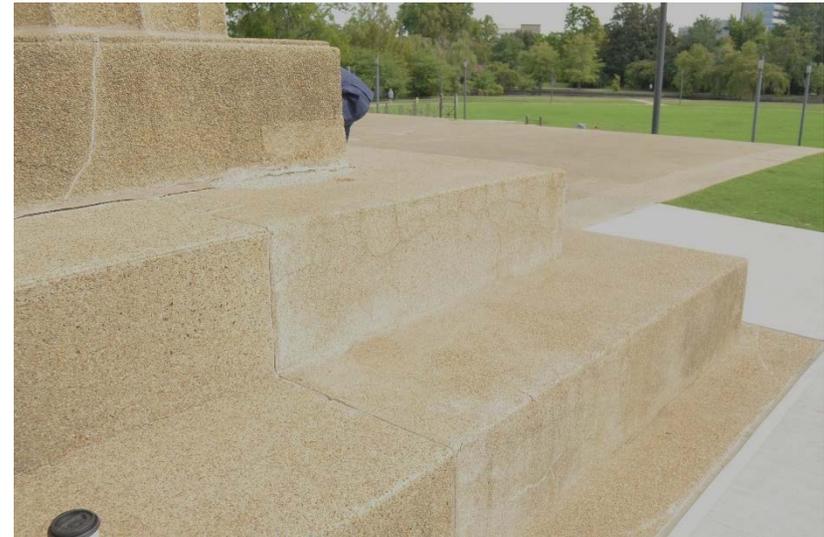
Figure 23: Southeast corner step looking east.

There are signs of differential movement between steps. Some appear to have been historic movements since the caulking, although no longer adhered to the concrete, does not appear to have moved differentially across joints. This is evident at the northeast and northwest corner steps and the eastern third length of the south elevation. At the northern steps between the third

and fifth easternmost exterior columns, however, the caulking has been torn, indicative of movement occurring after the caulking was placed. There is one spall at the northeast corner of the east elevation that could be a potential tripping hazard for visitors; this spall should be removed and repaired in the first phase of work.

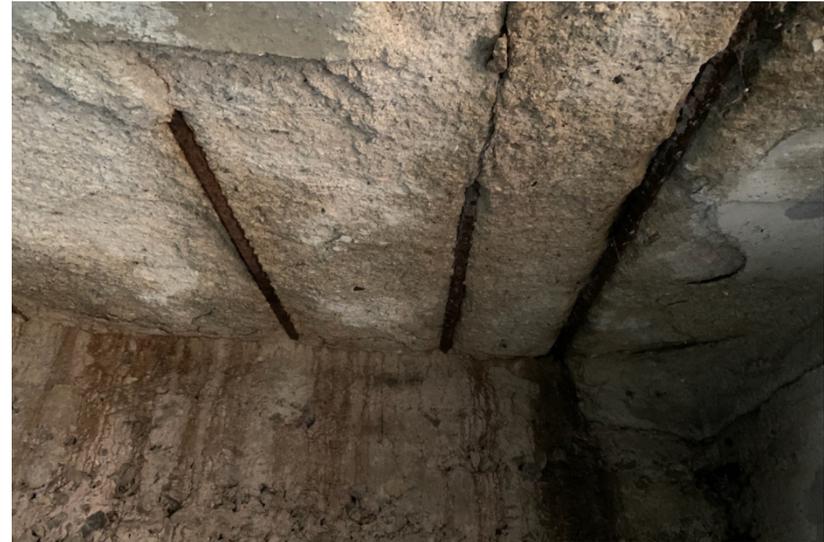
Figure 37: Location of Gunboat sample (interior) prior to falling off ceiling.

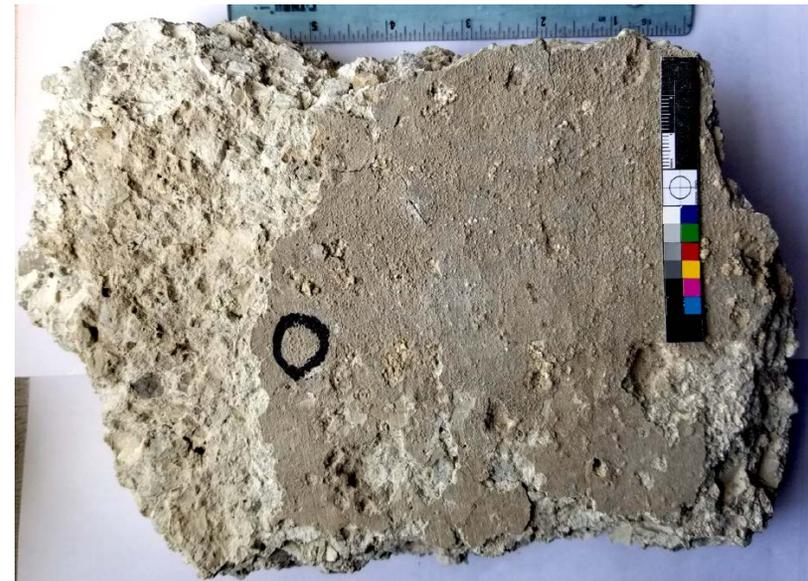
The finished surface is revealed to be irregular and map-cracked at low magnification. In cross-section the surface material is thicker than normal surface laitance typical of formed and poured concrete, but it may be that

Figure 38: Exposed surface (the visible ceiling) of the sample for petrography.

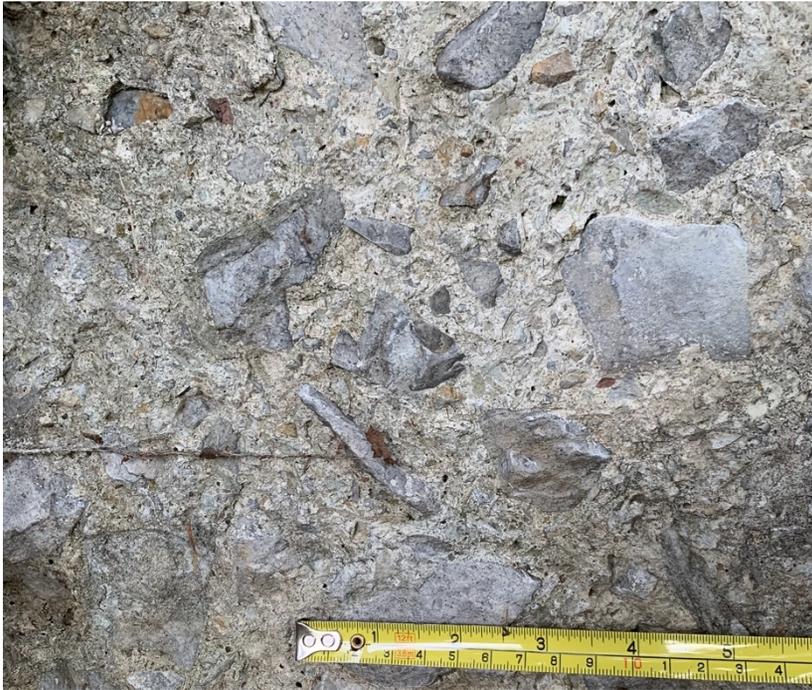
Figure 39: Unevenly distributed large aggregate in wall.

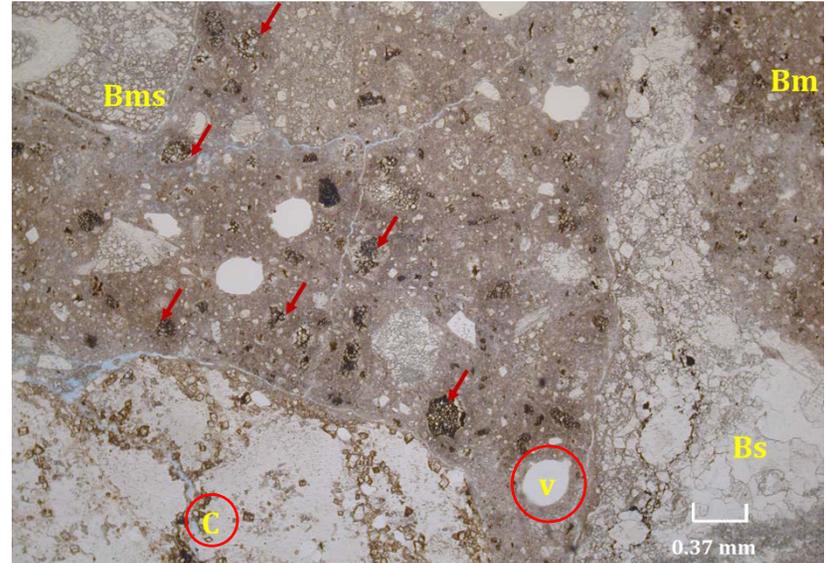
The matrix consists of cryptocrystalline calcium carbonate with abundant, large fully hydrated residual cement grains. The complete carbonation of the cement paste suggests prolonged exposure to moisture containing carbon dioxide; microporosity of the biomicrite aggregate may have played a role in the carbonation process. The matrix is extensively fractured both parallel and perpendicular to the original orientation of the concrete. The ratio of matrix to aggregate is estimated visually at 1:2.5.

Figure 41: View of thin section from Gunboat, 40x magnification in plan polarized light. C is chert; the other coarse aggregate grains show the gradation of texture of the limestone from biomicrite (Bm) through biomicroparite (Bms) to biosparite (Bs). The fine aggregate consists of fragments of each of these stone textures and individual rhombs of dolomite and fragments of calcite. The matrix (tan) is fully carbonated, and contains abundant, large residual cement grains consisting of alite, belite, and dark greenish brown ferrite (red arrows). Voids and cracks are filled with blue epoxy, or white where the resin did not penetrate (v).

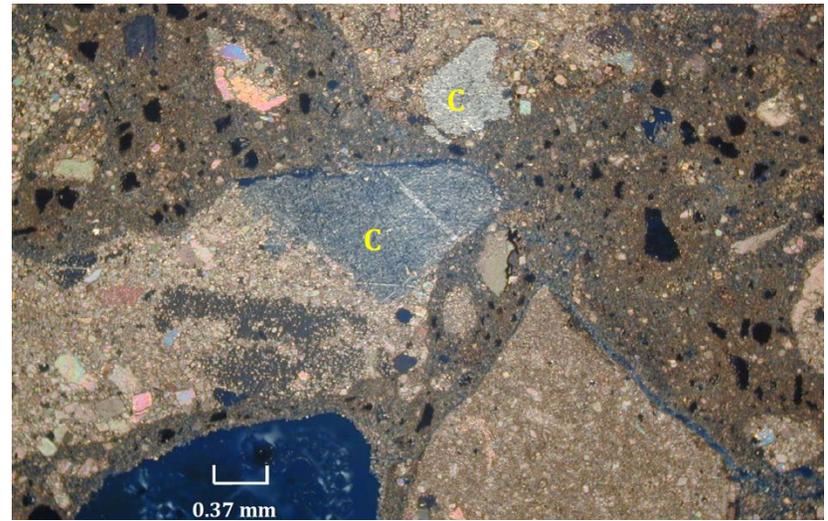
Figure 42: Thin section in cross polarized light. The upper and left aggregate grains contain chert (C).

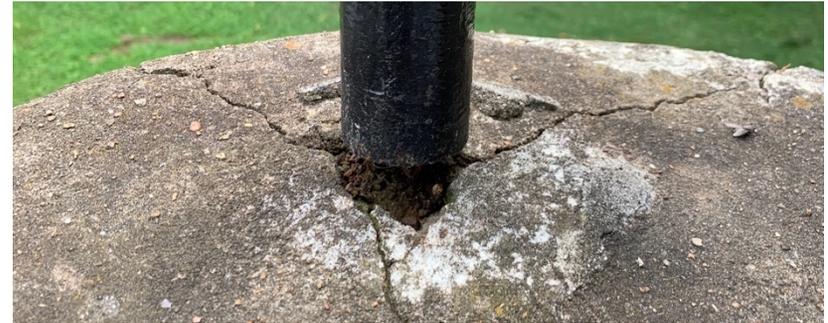
Figure 48: Similar condition of handrail posts to stair rail connection: corrosion is causing cracking and loss. Handrail must be removed, concrete repaired, rail restored and reinserted if it will be reused.

If the intent is to retain the extant metal railing along the parapet, it should be primed and recoated, including the steel anchor points if significant dimension still exists. If not, the railing anchors would require new stainless steel posts be attached. Where the posts were anchored into the concrete the previous patches should be removed, any steel routed out, the railing reset, and the concrete re-patched with an appropriate mix. Another option is to remove

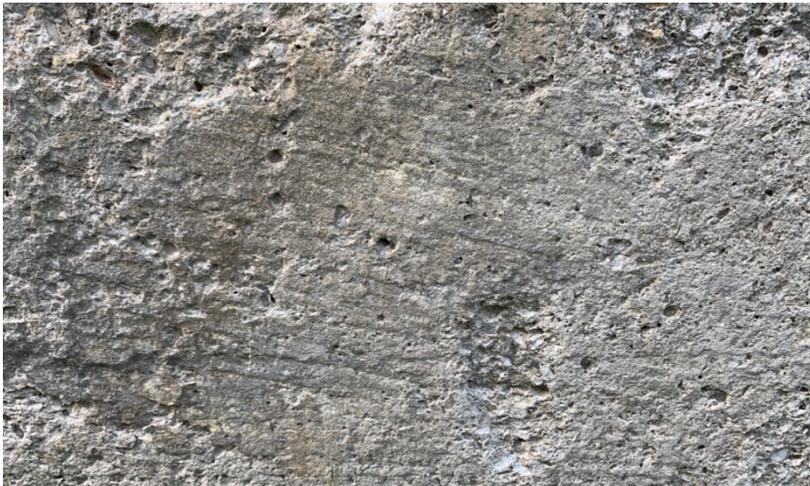
Figure 52: Possible original finish of Gunboat.

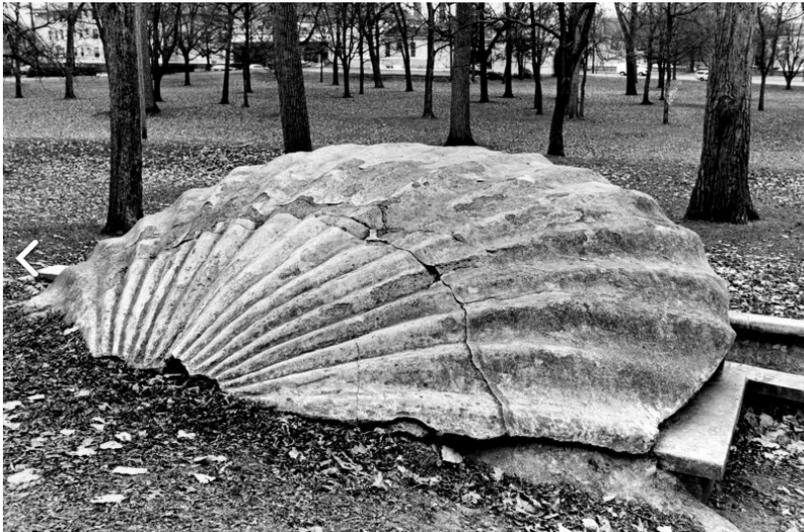
Figure 57: Screen shot provided by MHC, date unknown; the clamshell is largely intact though exhibiting cracks and a cold joint distinguishing concrete pours, and overall significantly less erosion.

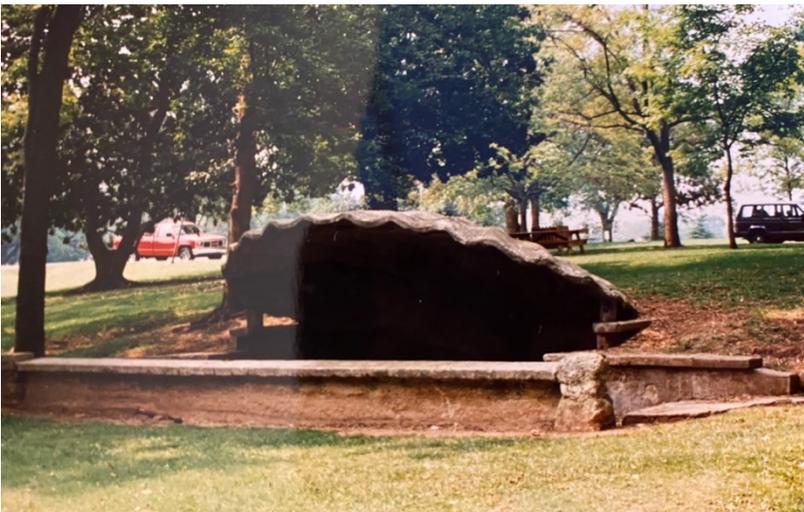
Figure 58: In this image the clamshell still retains much of its scalloped edge which is mostly gone today; date unknown.

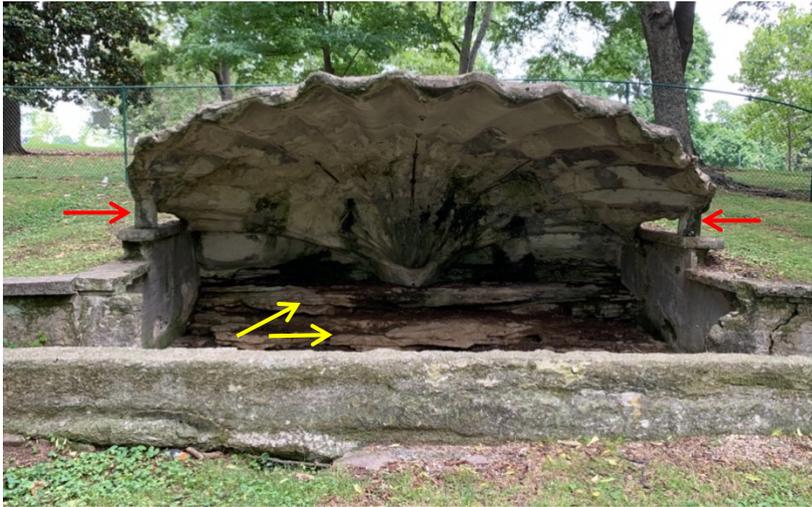
Figure 59: View to north: The complete retaining walls and stairs are not in the photo. The clamshell cantilevers (supported with the two short posts on either side at red arrows) over the grotto-like space where the spring flowed at the base. The shell sits on a tiered bed of limestone (yellow arrow) and is scalloped. The shell has conduit in it for now defunct lighting.

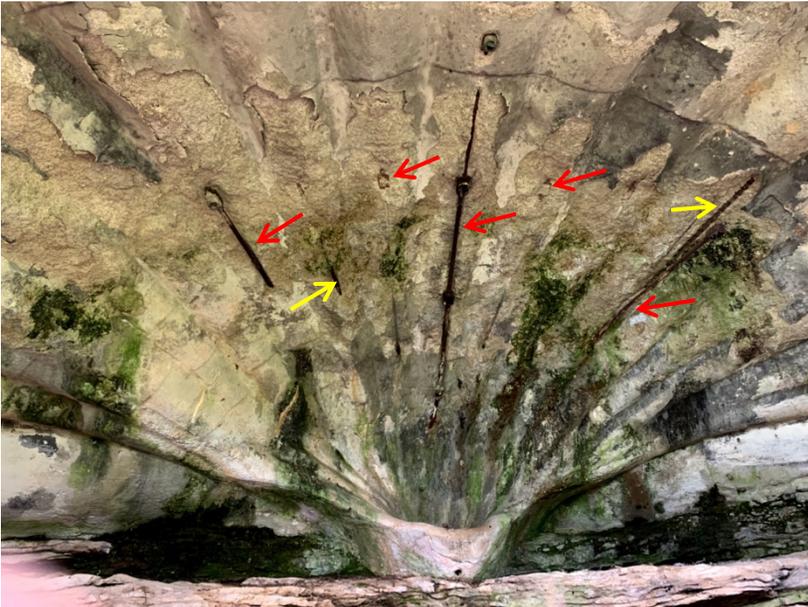
Figure 63: Interior lower portion of the shell. Red arrows indicate old conduit for lighting and yellow arrows indicate exposed steel reinforcement.

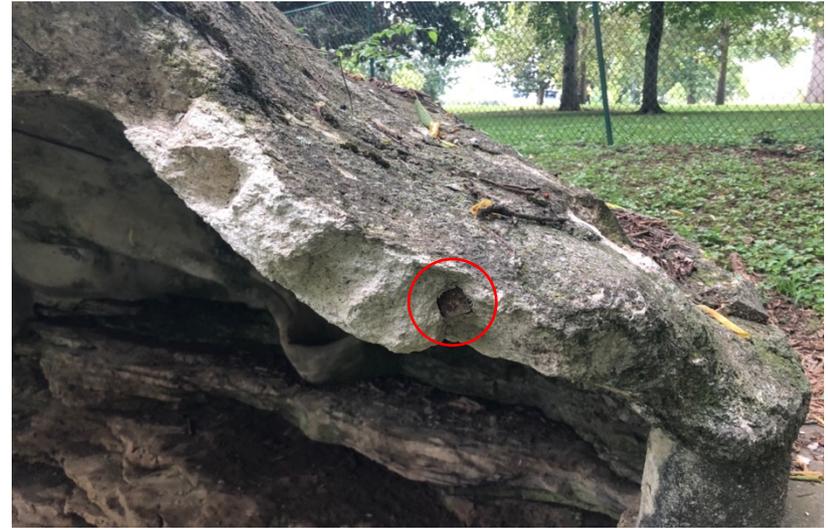
Figure 65: End of 1" square steel reinforcement bar (rebar) in red circle. Historically rebar could be square, or round, though today round ridged bars are typical. The square bars appear to be ridged as viewed from exposed rebar at the underside of the shell, but the outer rim of the shell and front retaining wall have exposed smooth round steel bars.

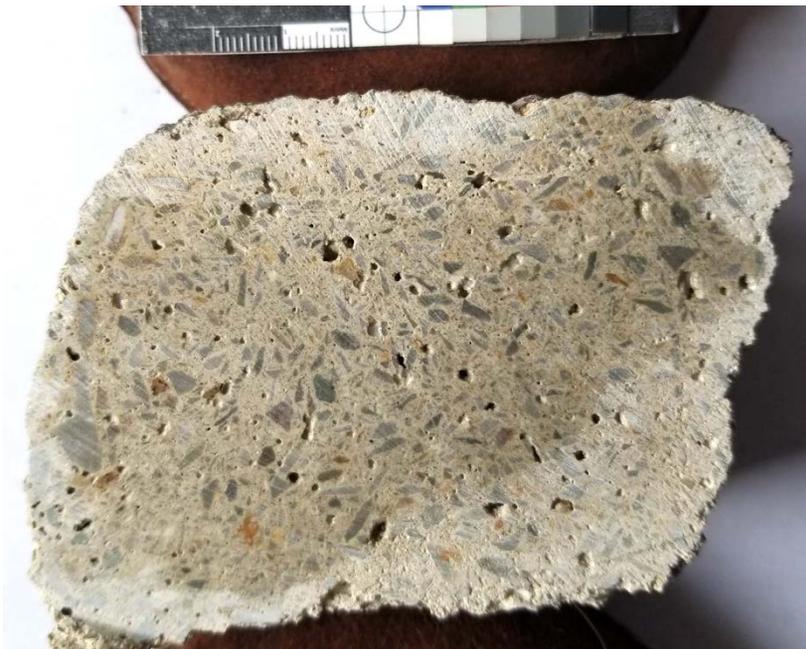
Figure 70: Cross-section of the sample after cutting - still wet. Note the small size of the aggregate throughout the sample. This was observed to be typical for the historic concrete at the Shell Spring. This would be deemed more similar to mortar than concrete.

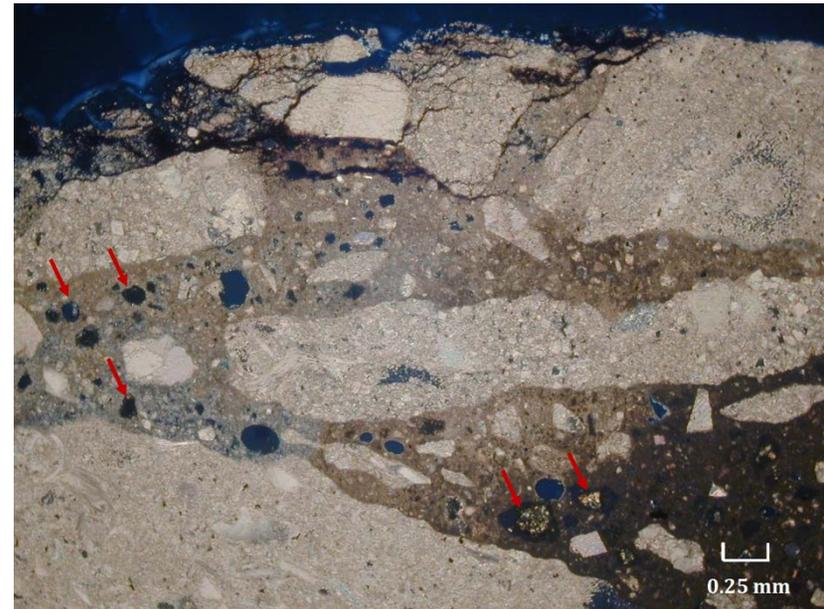
Figure 71: Shell Spring sample in thin section, 40x, xpl. The top face of the sample is at the top of the image. The matrix in this part of the sample shows partial carbonation; the carbonated paste is tan to light brown, and the uncarbonated paste is black. Voids are rounded to irregular and appear dark blue; some have linings of microcrystalline calcite or (more rarely) ettringite. The paste also contains partially- to fully hydrated cement grains (red arrows), some of which are very large. The aggregate is limestone, typically biosparite but also biomicrosparite to biomicrite. Note the fractures in the outermost aggregate and the paste, parallel to the surface; there are also small fractures in the aggregate deeper in and also in the paste parallel to the surface.

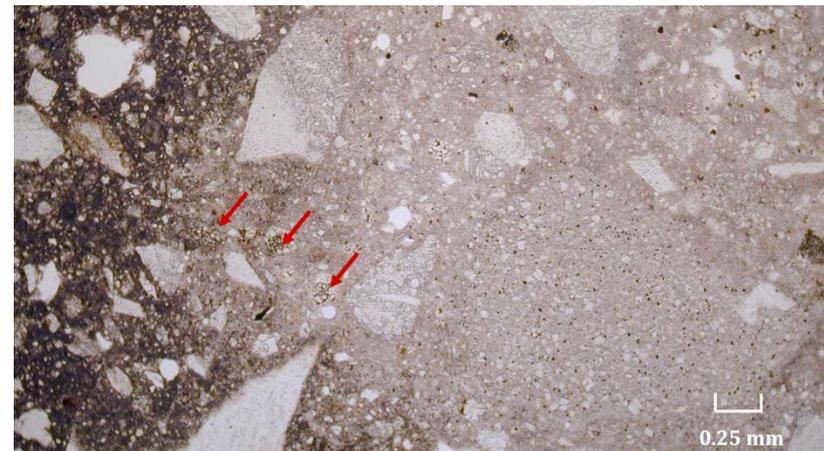
Figure 72: View of the Shell Spring sample near the interior face showing the extent of carbonation. 40x, ppl. Note the distinctive residual cement grains in the carbonated paste near the boundary between the carbonated and uncarbonated paste (red arrows).

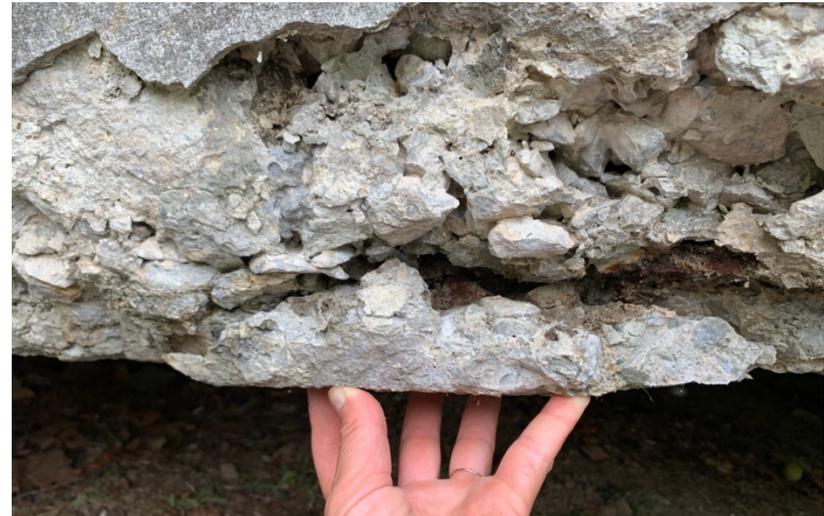
Figure 87: Sample just after removal at corner of bridge bottom at the west elevation.

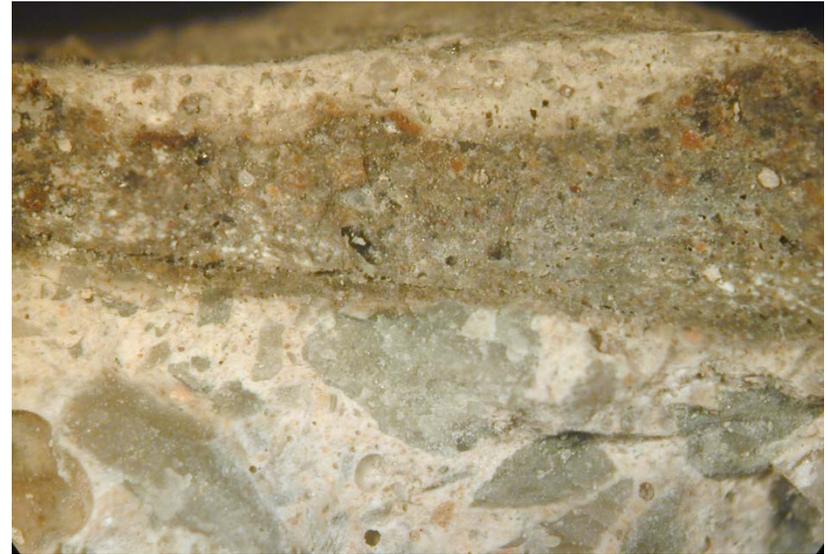
Figure 91: View of a cross section through the parge on the bottom surface showing the two layers of cementitious coating material. 12x, reflected light. Also note the character of the fine aggregate and the small, spherical voids in the binder.

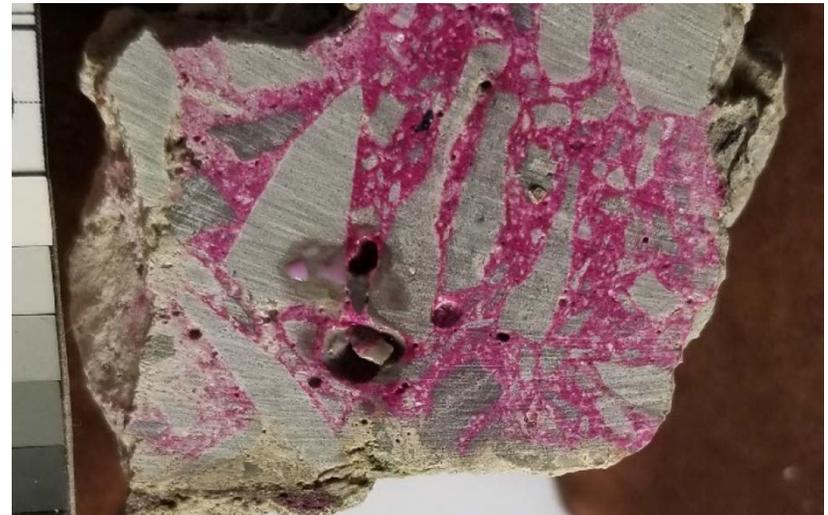
Figure 92: View of a fresh cross section of the 1910 Concrete Bridge sample, treated with phenolphthalein. The bottom of the sample is at the bottom of the image. The depth of carbonation from the bottom is approximately 1/8".

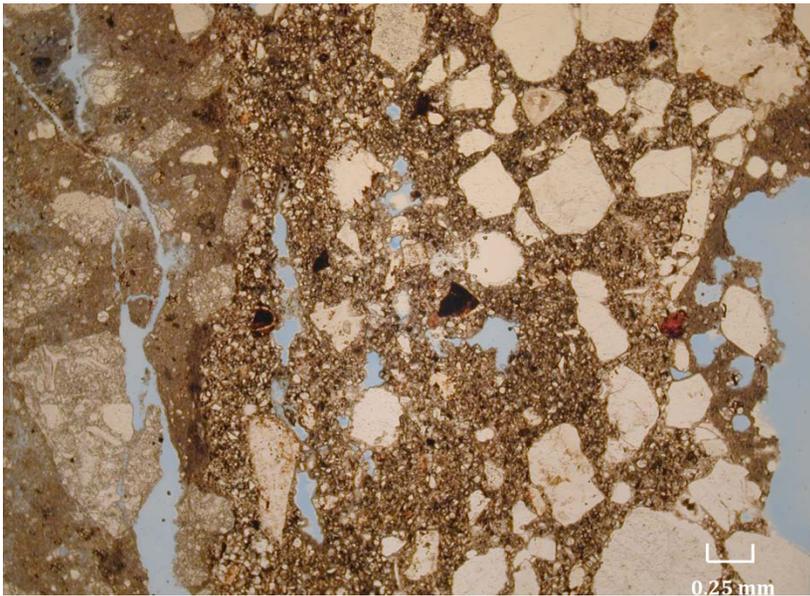
Figure 93: The texture of the parge is due to the abundance of unhydrated cement residuals, ppl.

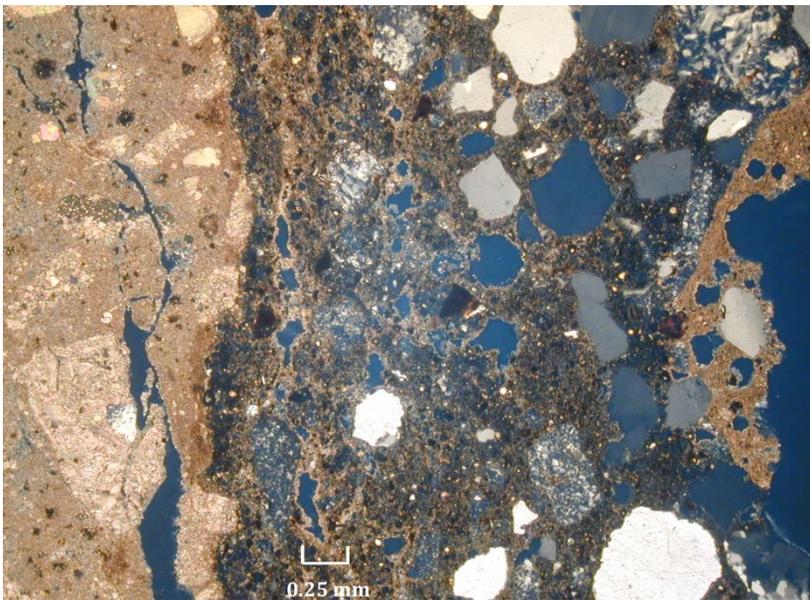
Figure 94: Concrete Bridge in thin section, 40x. The image shows the bottom of the sample to the right with two separate layers of parging on top of fully carbonated concrete. This is the same view as above but in cross-polarized light.

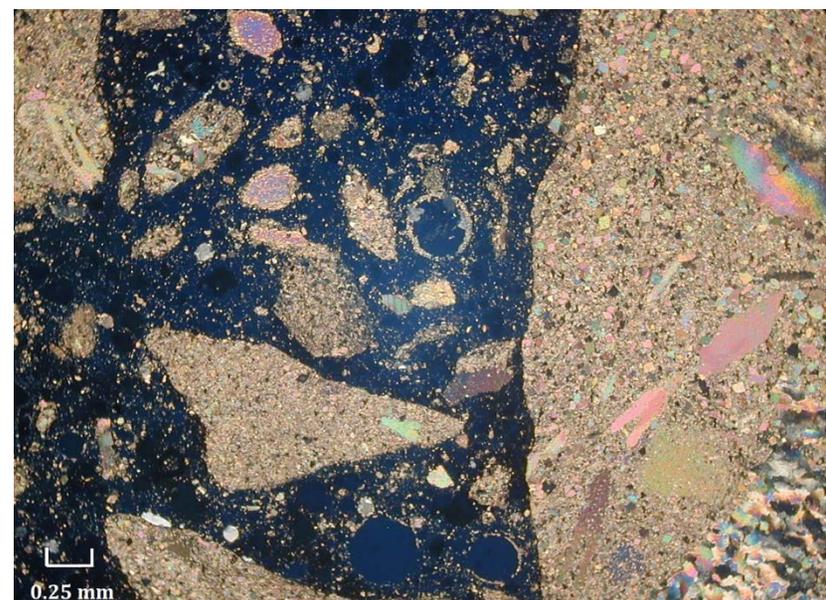
Figure 96: Showing the character of the paste. Note the spherical void at the upper center lined with salts; the voids near the bottom of the image have thin rims of microcrystalline calcite. 40x; same view as above in cross-polarized light.

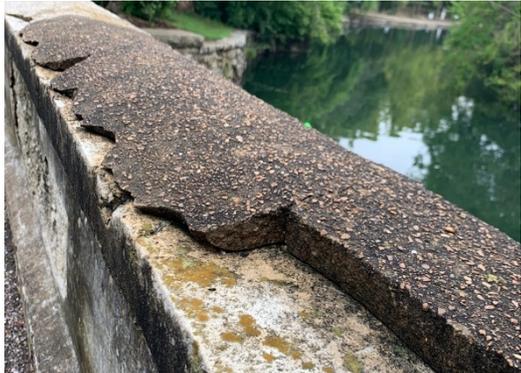
There is a later repair campaign that is failing at the east railing top. It appears as if the railing was originally poured with a shallow slope on top and the repair effort re-created an arched top to shed water. The repair is largely failing, which will aid its removal, because the historic concrete was not properly prepared to receive a successful topping. Once the repair is removed it should be assessed on how to proceed – whether to reintroduce the topping or leave it be. The west railing has retained the original profile and appears to be performing well.

850 SF	1	\$34,000
Remove top rail previous patch	70% of east top rail has a failing patch that needs to be removed. Reinstalling a patch should be considered to shed water but might require scarifying the historic concrete to get a mechanical key for the topping that is currently lacking and inducing failures. The top should be assessed after repair removal.

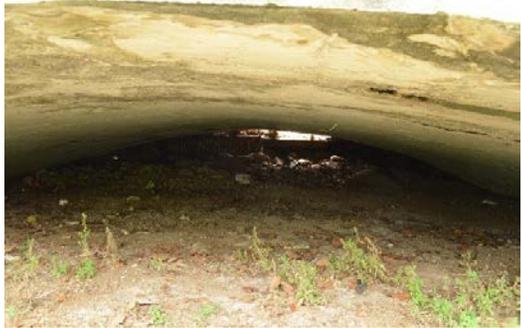
The site wall at the west end of the bridge appears to have failed toward the north end, leaving the east end of the site unretained/unsupported.

40 LF	I	n/a
Site retaining wall repair	Repair retention wall and high grade at west side of bridge; entire length of exterior west elevation of bridge.

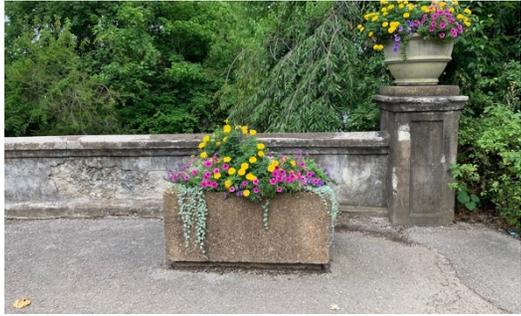
The pavement over the bridge is cracked in multiple directions and the current drainage pattern is for runoff to run toward and along the base of the side railings. The railings have observed moisture damage along their bases, as do the four end posts, with areas of cracking and spalling due to moisture ingress and freeze thaw. The pavement also encases some portions of the footing of the bridge railings and posts. This is detrimental to the long-term preservation of the bridge. Drainage should be assessed and designed so water does not get directed to the historic concrete.

40 LF	I	n/a
Site Drainage	Assess movement of water on bridge pavement and along west elevation adjacent to high grade to avoid continued base deterioration.

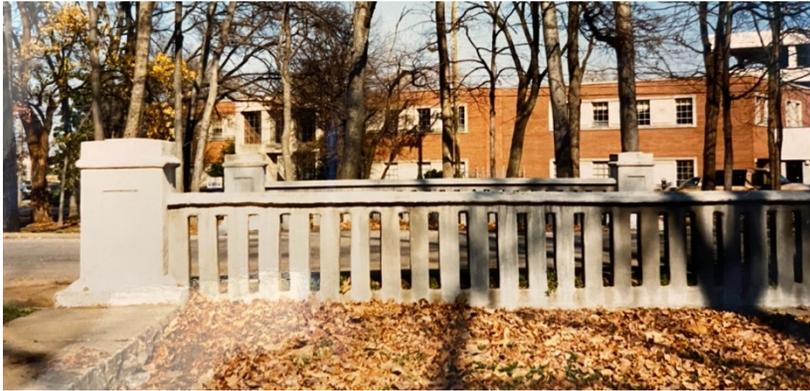
Figure 102: Undated image; note more recent parging on concrete and lack of planters on the posts.

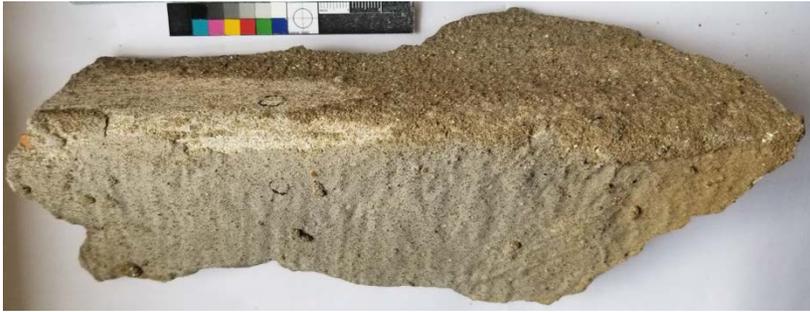
Figure 108: Sample outer surfaces; note multiple parge coats indicating different repair campaigns.

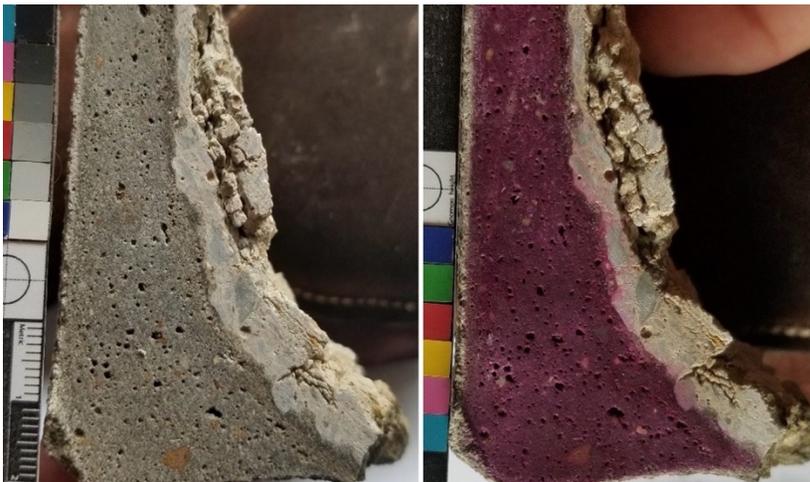
Figure 110: Left: Fresh cross section of the sample. The inner, white material is the original concrete; the outer, gray-brown material is a later repair. Note the fracturing in the concrete subparallel to the surface parging. Right: sample treated with phenolphthalein: original concrete is colorless.

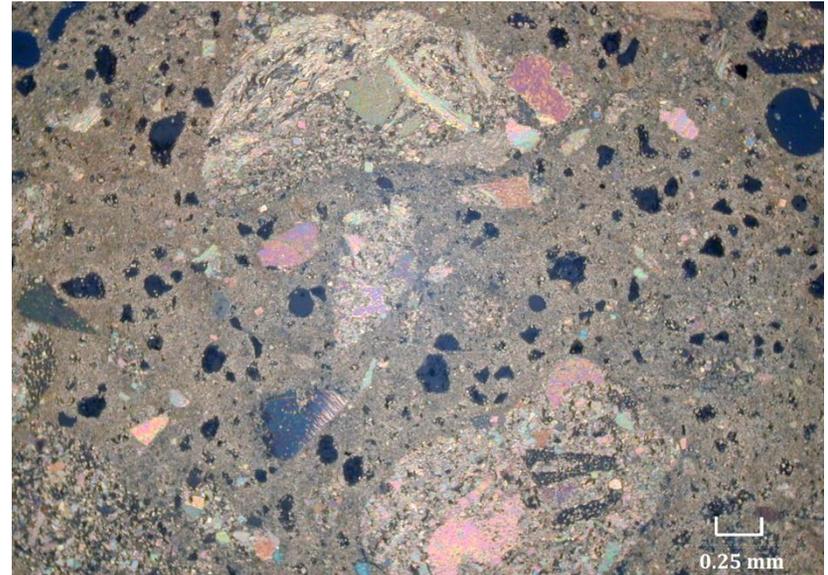
Figure 111: The concrete (not the surface parging) in thin section, 40x, xpl. The matrix is fully carbonated with large, hydrated residual portland cement grains.

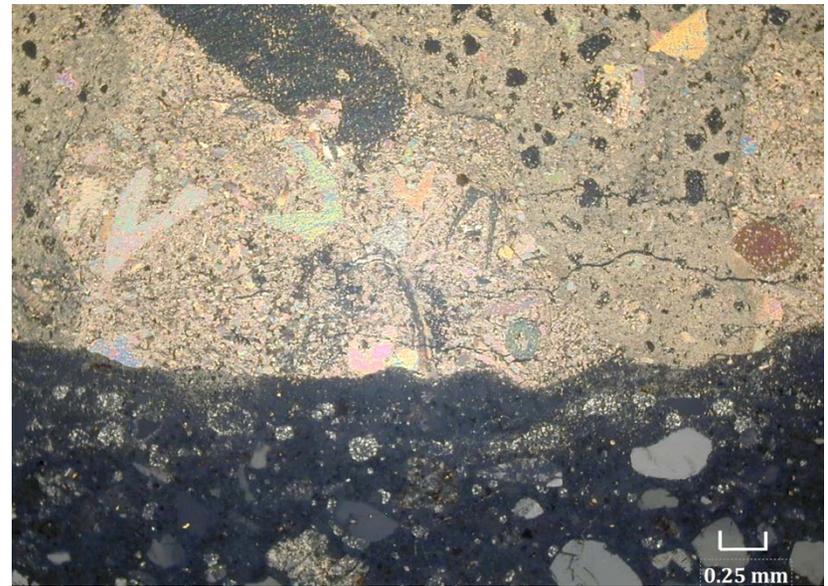
Figure 112: View of the boundary between the thick, outer surface parge and the inner concrete of the Lick Branch Bridge sample in thin section, 40x, xpl. Note the cracking in the concrete that extends through the aggregate. There is a zone of salt-filled voids in the parge immediately adjacent to the concrete.

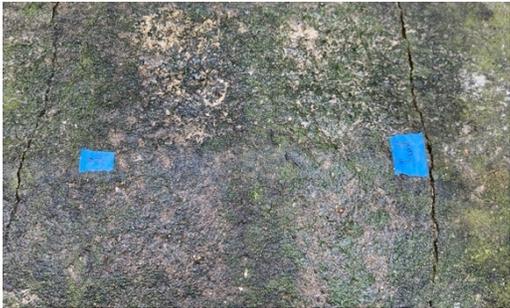
BRIDGE AT LICK BRANCH SEWER					
Scope	Notes	Image	Quantity	Priority	Cost Estimate
Cleaning	The biogrowth is obscuring the surface so it is difficult to discern conditions; biogrowth also holds moisture to the surface which accelerates deterioration. Testing had limited results but the use of a pressure washer and multiple applications or different products can be tested.

As a first step, it is recommended the bridge get cleaned with appropriate materials and methods. This will allow for work to be executed and for future monitoring depending on the preservation approach implemented.

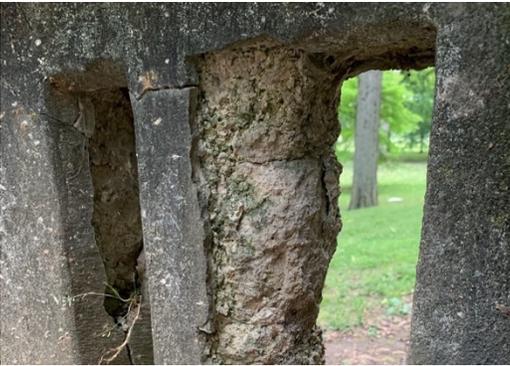
There is a newer parge coat over the majority, if not all, of the historic concrete and/or over a possible historic/original parge coat. It is failing in several places such as on all the posts and on 13 balusters. In locations where the historic concrete is visible it is scaling, cracked, disaggregated, and exhibits dimensional loss. Some of the concerns are whether this newer parging is too dense for the historic concrete beneath it or if it is contributing to the preservation of the historic concrete. Petrographic analysis revealed the surface of the historic concrete is carbonated but the parging is not which offers protection to any steel reinforcement within the historic concrete. As discovered by sampling, the parging, in places, is well-adhered to the historic concrete and its removal will also remove original concrete.

350 SF	I	\$15,000
<b>BALUSTERS</b>					
Option 1: Repair 14 balusters	Repair 14 balusters Injection grout Fill cracks Patch Select removal & re-parge

14 units	I	\$20,000
Option 2: Remove and replace 11 balusters	Remove and replace 14 balusters; on west and one on east.		40 CF		\$25,000

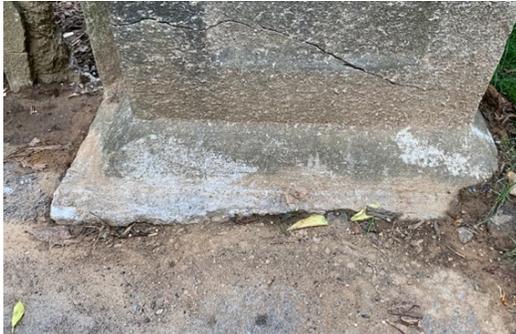
The area around the base of the railing should also be cleared of dirt and debris and drainage should be considered. The east side of the west railing at the north end has the majority of the disrepair and it appears after a rainstorm that area pools water so the wicking of the moisture accelerates the deterioration of the concrete. In winter this can become freeze/thaw which also accelerates the decay of concrete.

200 SF	1	\$8,000
Patch structural concrete	Includes the prep/any cut back needed for suitable patch		50 SF	1	\$6,000
Injection grout & Patch parge	Grout the cracks and apply parging where removed.		100 SF	1	\$8,000
SITE					
Site Drainage Considerations	removal of soil and asphalt adjacent to base of railings for concrete work and to avoid continued base deterioration
